# CATANIA HARBOR BREAKWATER: PHYSICAL MODELLING OF THE UPGRADED STRUCTURE

Martina Stagnitti<sup>1</sup>, Claudio Iuppa<sup>2</sup>, Rosaria Ester Musumeci<sup>3</sup> and Enrico Foti<sup>4</sup>

Keywords: rubble mound structures; restoration; damage progression; overtopping

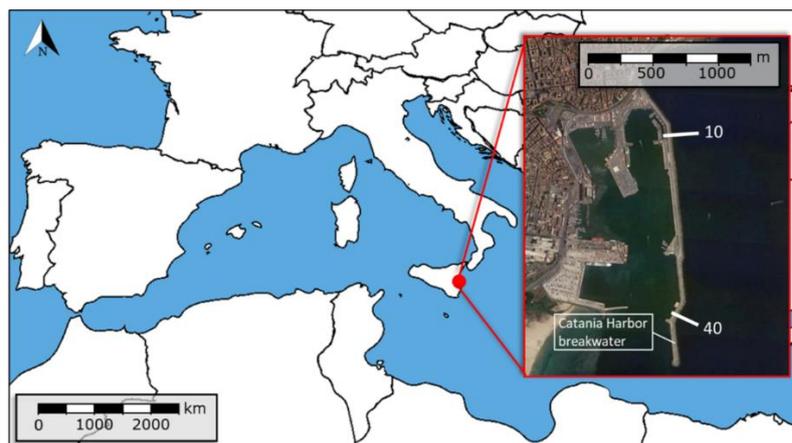
Figure 1. Location of the Catania Harbor (satellite view from Google Earth) and indication of the outer breakwater representative sections n. 10 ( $H_{s,Tr=100}h=0.38$ ;  $k_{Tr=100}h=0.50$ ) and n. 40 ( $H_{s,Tr=100}h=0.36$ ;  $k_{Tr=100}h=0.60$ ).

The Harbor of Catania is located on the East coast of Sicily, in the middle of the Mediterranean Sea (see Fig. 1). The strategic position, which is equidistant between the Suez Channel and the Strait of Gibraltar and between the European and the North-African ports, made the Harbor of Catania one of the Italian commercial ports of national interest, with its operative piers of about 4.2 km total length. At present, the harbor basin is mainly protected by the 2.25 km long outer breakwater of Levante, which during its lifetime was subjected to several structural interventions that had modified its composition and length.

Two representative sections of the breakwater were tested, i.e. section n. 10 and n. 40 (see Fig. 1). Section n. 10 was selected because of its strong geometric irregularities and it is characterized by a ratio between the 100-year return period significant wave height and the water depth ( $H_{s,Tr=100}/h$ ) equal to 0.38 and a product between the 100-year return period wave number and the water depth ( $k_{Tr=100}h$ ) equal to 0.50. Section n. 40 was chosen because it is representative of the most offshore (i.e. exposed to the wave load) part of the breakwater and it is characterized by a  $H_{s,Tr=100}/h$  equal to 0.35 and  $k_{Tr=100}h$  equal to 0.60. For each of the two sections, the six upgrading solutions summarized in Table 1 were tested.
