36TH INTERNATIONAL CONFERENCE ON COASTAL ENGINEERING 2018

VIOLENT IN-CHAMBER LOADS IN AN OSCILLATING WATER COLUMN

Krisna Adi Pawitan, Ben Gossling, William Allsop, Tom Bruce

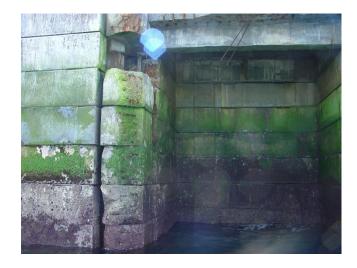
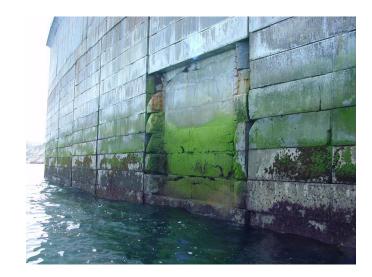
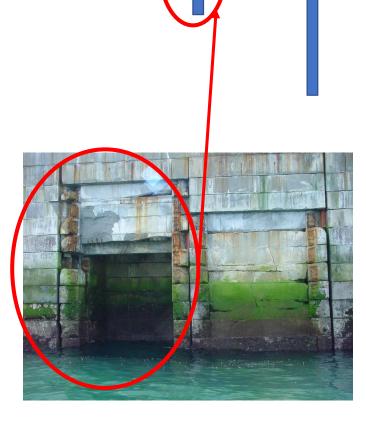
Damaged Mutriku wave power plant during construction due to storm Image: courtesy of Ezter Horvarth

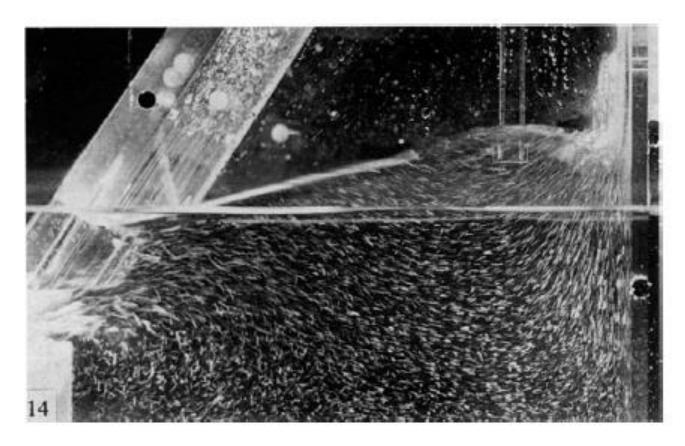
Fig. 14. Impact of breaker on back wall.
