# WAVE OVERWASH ON A ROCK PLATFORM: REMOTE SENSING AND PRESSURE SENSOR OBSERVATIONS

The Figure 8 Rock Platform is located approximately 40 km south of Sydney, Australia and is exposed to open ocean swell (Figure 1; Kinsela et al., 2017). The site features unique pools that have been weathered into the platform and is a site that is visited by national and international tourists. Recent increases in visitation and visitor injuries have led to a project to develop a predictive model for wave overwash hazards at the site. This paper uses video remote sensing and pressure sensor observations to assess the wave overwash and wave energy dissipation across the rocky shore platform with comparisons with offshore wave rider buoy data.

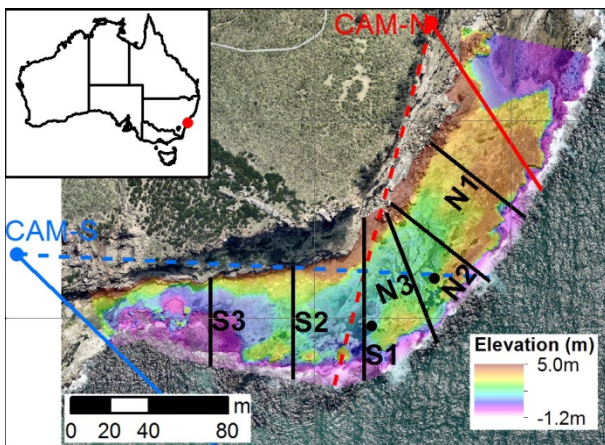
Figure 1 - Site map showing the two camera locations (red and blue dots) and their fields of view (red and blue lines) along with the six cross-platform transects analysed using video data (N1, N2, N3, S1, S2, and S3; black lines) and the locations of the two pressure sensors (black dots).

Two low cost camera systems were installed at the site in March 2017. Both systems recorded snapshots at 1 Hz for 20 minutes of each daylight hour until August 2017. Snapshots were rectified using ground control points and timestacks of 20 minute durations were created along six cross-platform transects (Figure 1). Pixel values in the timestacks were converted to a percentage of time of inundation using a combination of pixel lightness and pixel colour temperature (e.g., Figure 2a). For the period 29 March to 7 April 2017, two pressure sensors were deployed in the rock pools at the site that recorded continuously at 8Hz for the duration of the deployment. During this period, nearshore significant wave height peaked at 2.99 m and depths on the platform exceeded 3 m (see Figure 2). In the conference presentation, we examine the relationship between offshore wave conditions and the degree of wave overwashing on the rocky shore platform to assist in the development of a hazard warning system.

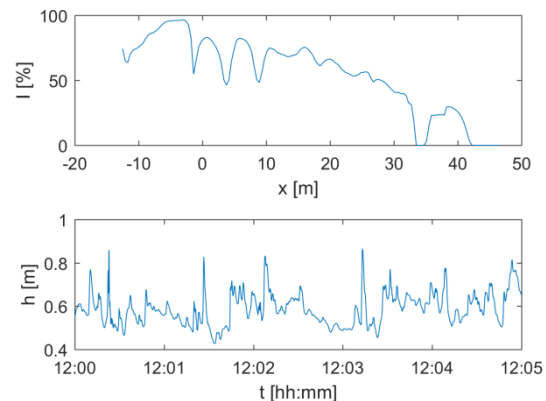
Figure 2 - (a) Percentage of cross-platform inundation (I) along transect N2 on 2 April 2017 at 12:00-12:20pm. (b) Depth over the platform (h) as recorded by the northeastern pressure sensor on 2 April at 12:00-12:05pm.
