CHAPTER 32
HISTORY OF COLUMBIA RIVER JETTIES

R. E. Hickson and F. W. Rodolf
Portland District, Corps of Engineers
Department of the Army
Portland, Oregon

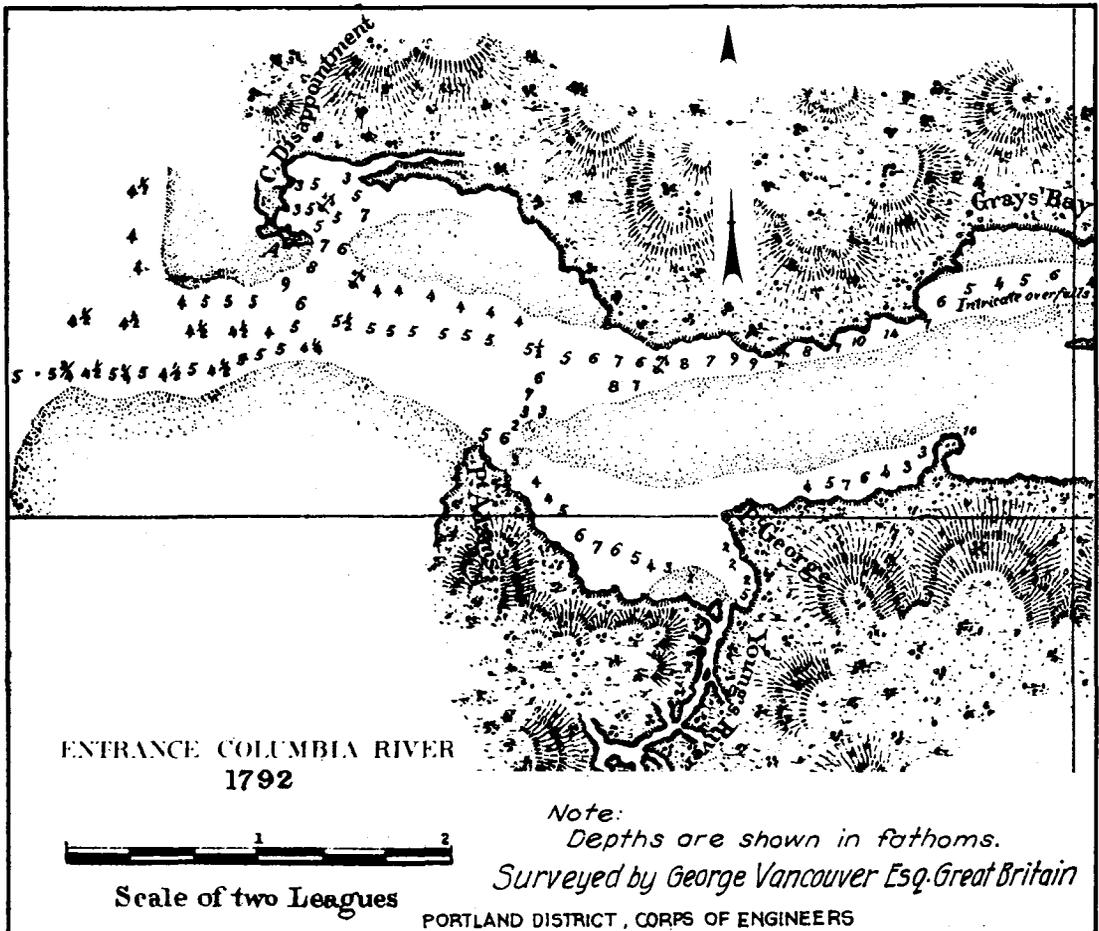
Fig. 1

The earliest known chart of Columbia River at the mouth is a sketch made by Admiral Vancouver in 1792, shown in Fig. 1. The next known survey was made by Sir Edward Belcher in 1839, shown in Fig. 2. Condition of the river entrance in 1885, before construction was started on the south jetty, is shown in Fig. 3. The shoals, bars, and beaches at the river entrance are composed of a sand that is readily shifted in location by wave action, currents, and wind. Before construction of the jetties, both Clatsop Spit and Peacock Spit were constantly changing in position and depth. Inspection of Figs. 1, 2, and 3, shows that the direction of Clatsop Spit had varied from westward, with a length of nearly 8 miles in 1792, to northwestward, with a length of 3-1/2 miles in 1885. In 1839 its northern edge was but 1/2 mile north of Point Adams, while in 1885 it was 2-1/2 miles. The

The set of the main channel ebb tide is to the southwest at all seasons, and the channel to the ocean has consistently remained across the southwest quadrant of the bar; the only exceptions to this rule having been the channel shown by Admiral Vancouver's sketch of 1792, and deteriorating channels that have worked around to a northerly direction. The northerly movement of Clatsop Spit and the river gorge, while the channel across the bar remained in the same general location, increased the length of the main channel until it was much greater than the distance between deep-water curves measured directly across the root of Clatsop

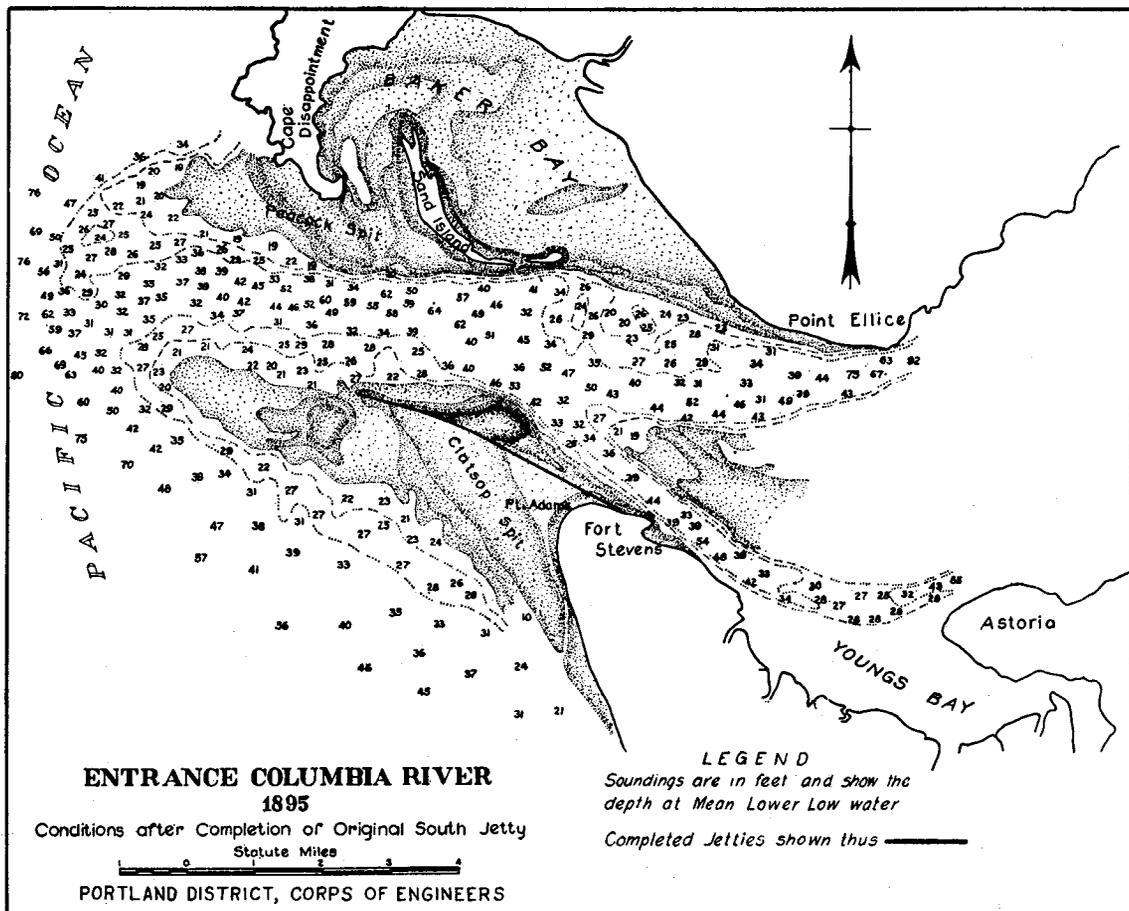
Conditions at the entrance in 1895, when the original south jetty was completed, is shown in Fig. 4. Deterioration of the channel by 1902 is shown in Fig. 5. Improvement of the channel by the time the extension of the south jetty was completed in 1913, and when the north jetty was 90 percent completed in 1916, is shown in Figs. 6 and 7, respectively. The condition of the entrance in 1950 is shown in Fig. 8.

let had been closed off and the northern portion of the swash channel became a lagoon separating the new beach from the beach along the ocean side of Point Adams. Fig. 3 (1885) shows the swash channel before the south jetty was built across it. Fig. 4 (1895) shows the sand accumulated on the middle ground and the southern portion of the channel narrowed to near closure. Fig. 5 (1902) shows the remaining portion of the swash channel as a lagoon in the triangle formed by the old beach

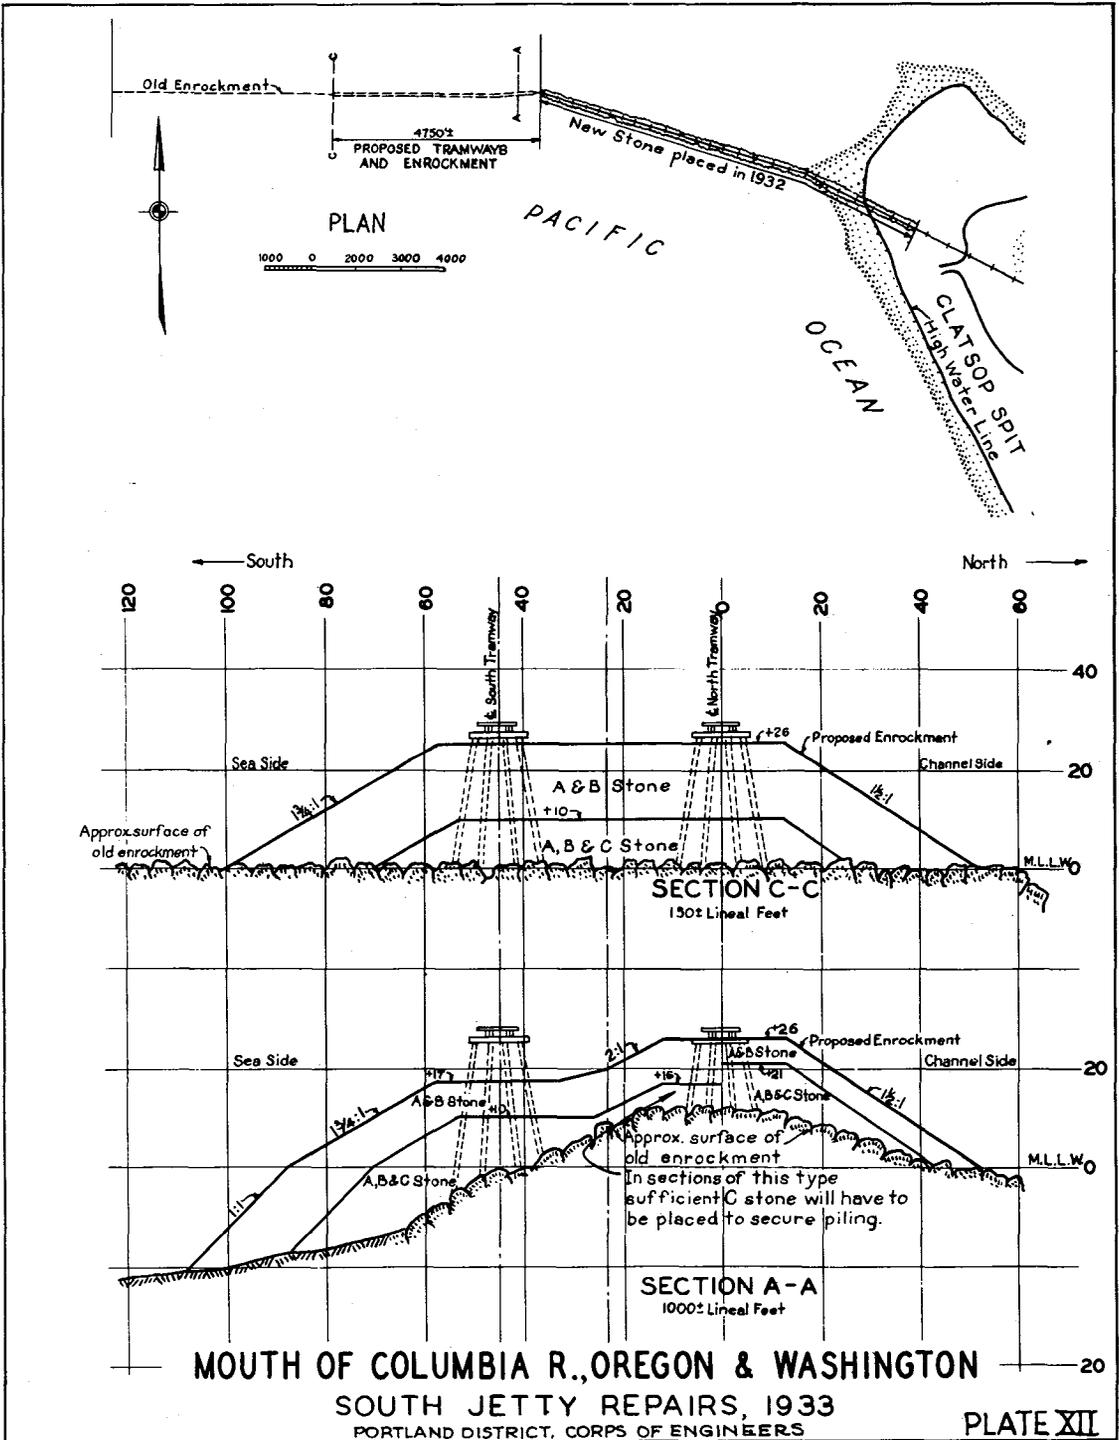
Fig. 9

The south jetty as now constructed is a massive structure (see Figs. 9, 10, and 11). The top width varies from 45 ft. to 70 ft., with an elevation of 26 ft. above mean lower low water. The sea slope is approximately 1 on 1-1/2 consisting of stone weighing up to about 25 tons, with 45 percent of entire enrockment having an average weight of 10 tons to the piece. The base width of the outer portion is approximately 350 ft. and the total height from bottom ranges up to 76 ft. The outer 3,900 ft. have been beaten down to 10 or more feet below low water and rebuilding is not believed to be necessary. This outer section, in depth of 70 ft., serves as a protective apron.

As the new beach line of Clatsop Spit was raised above high water, the sand surface was exposed to erosion by wind. Following the initial accumulation and advance of the shore line seaward along the south jetty, as previously alluded to, recession of the shore line has proceeded steadily up to the present time. Wind transportation is an important factor in eroding the beach, but sand fences and grass plantings are now successfully used to limit, to some extent, the amount of sand transported by winds and the distance the sand is transported. There appears to be a southerly littoral drift of sand inside the line of breakers during the summer months and some sand has accumulated on the southern end of the beach in front of the city of Seaside since the jetty was constructed. The recession of the beach has been mostly limited to an area extending about 3 miles south of the jetty. The total recession, normal to the beach line, has been about 2,000 ft., just south of the jetty, and about 1,000 ft., 2 miles south (see Fig. 9).

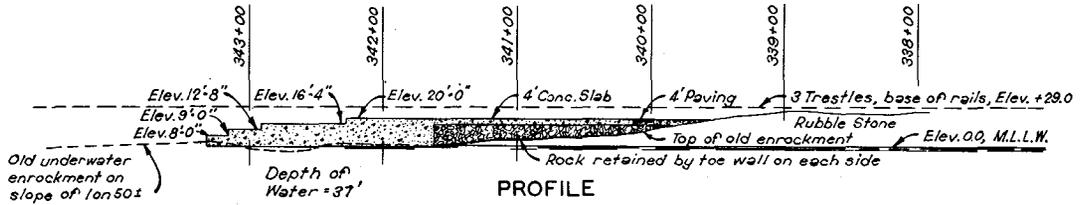
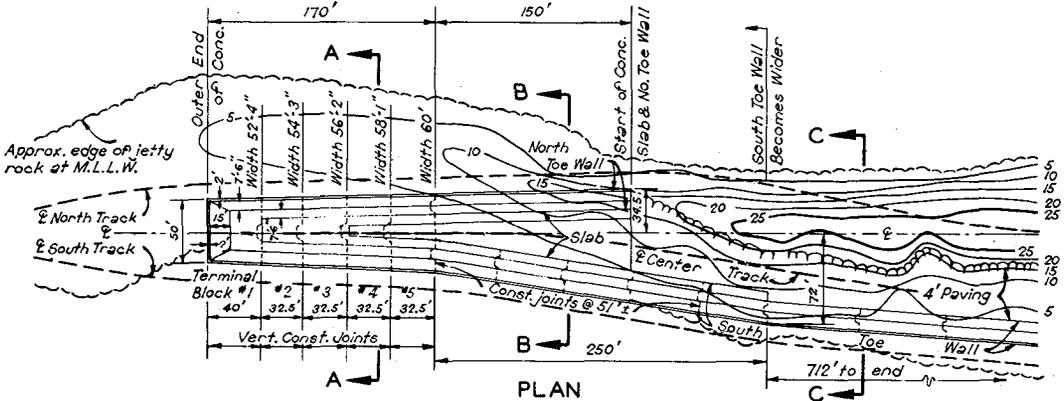
Fig. 10

MOUTH OF COLUMBIA RIVER, OREGON AND WASHINGTON SOUTH JETTY TERMINAL

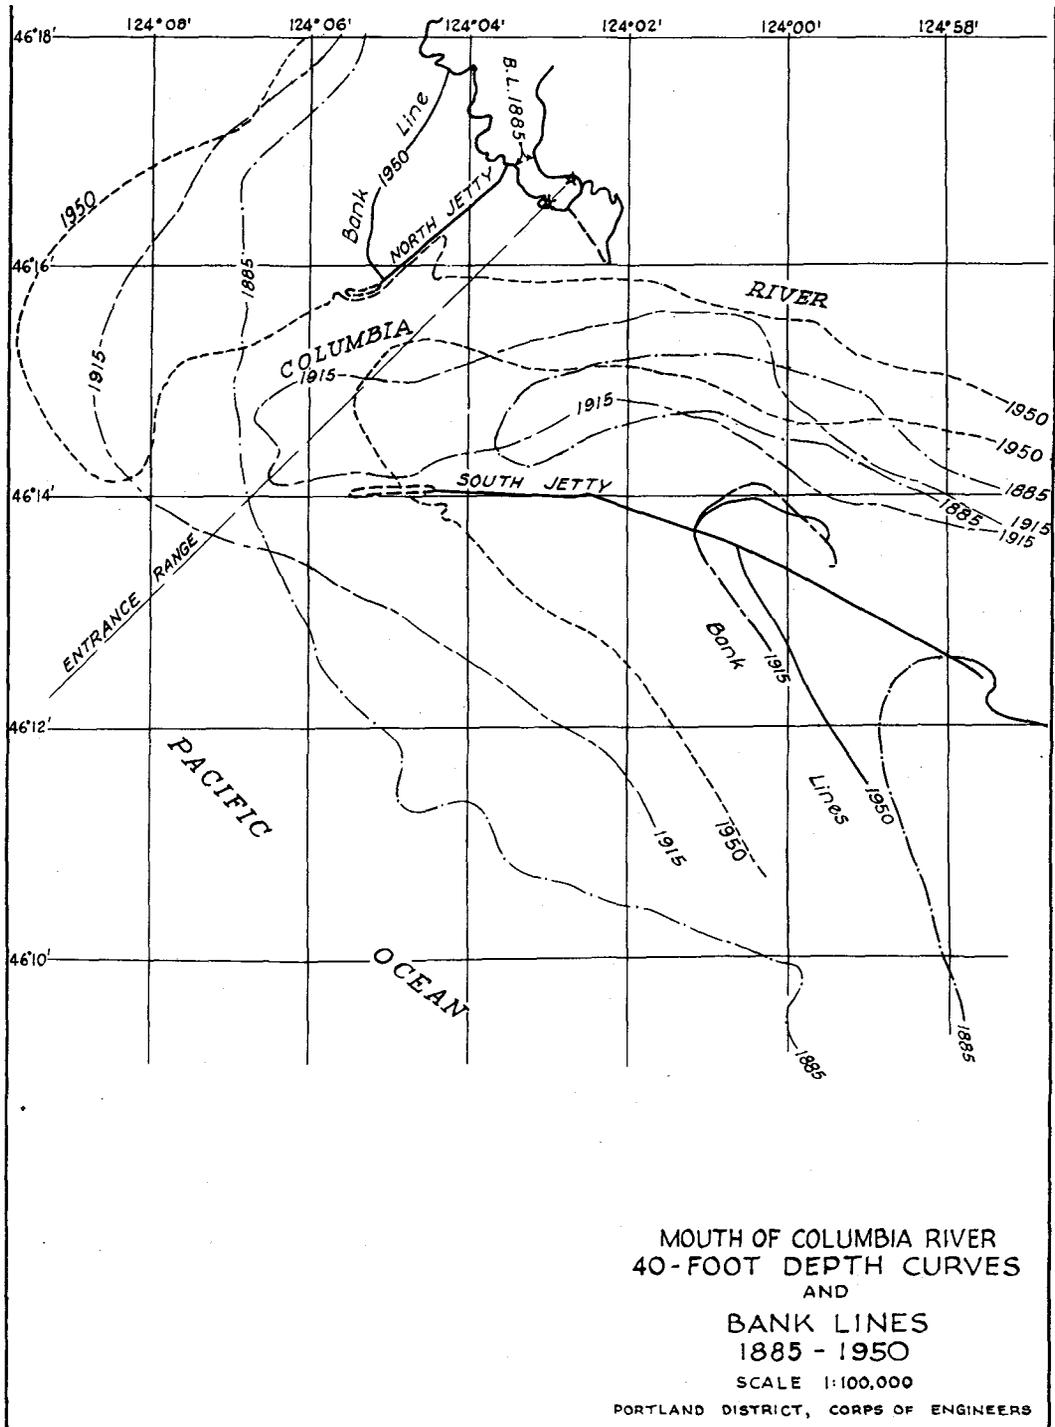
In 1885 the outer face of the bar was approximately 3 miles west of Cape Disappointment. Construction of the jetties forced the bar further into the ocean so that by 1900 the outer face had advanced 1 mile, and by 1950 the extreme western position of the sea face of the bar was over 5 miles west of Cape Disappointment. As the outer perimeter of the bar advances into the ocean the original depth of water increases and the rate of advance becomes less. Fig. 12 shows the advance seaward of the 40-ft. depth contour since 1885.
