COASTAL ADAPTATION IN THE DEVELOPING WORLD: A CASE STUDY IN DURBAN SOUTH AFRICA

Marli Geldenhuys , Aurecon/Delft University of Technology, <u>marli.geldenhuys@aurecongroup.com</u> Mathijs van Ledden, Royal Haskoning, <u>m.vanledden@royalhaskoning.com</u> Bas Jonkman, Delft University of Technology/Royal Haskoning, <u>s.n.jonkman@tudelft.nl</u> Marcel Stive, Delft University of Technology, <u>m.j.f.stive@tudelft.nl</u> Rosh Ranasinghe, UNESCO-IHE/Delft University of Technology, <u>r.ranasinghe@unesco-ihe.org</u>

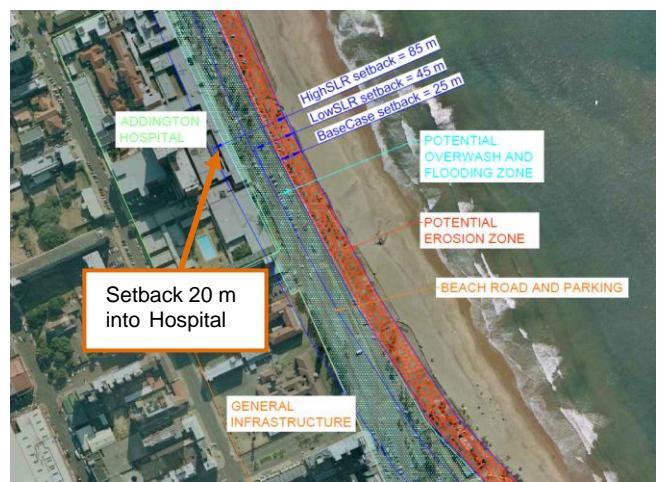
Figure 1: Areas potentially affected by erosion and flooding during a 1 in 100 year storm event

An attempt was made to quantify the impact of these coastal processes at the case study location by delineating coastal hazard setback buffers (as shown in Figure 1). The main causes of coastal damage are expected to be beach erosion, coastal flooding and pollution. Storm debris and damage to infrastructure such as the sewage network also have significant impacts.
