INCORPORATING CLIMATE CHANGE RESILIENCE INTO A BREAKWATER REPAIR: A CASE STUDY AT HILO, HAWAII

Jessica H. Podoski, P.E., US Army Corps of Engineers Honolulu District, jessica.h.podoski@usace.army.mil
Chris Goody, P.E., Sea Engineering, Inc., cgoody@seaengineering.com
David Smith, Ph.D., P.E., Sea Engineering, Inc., dsmith@seaengineering.com

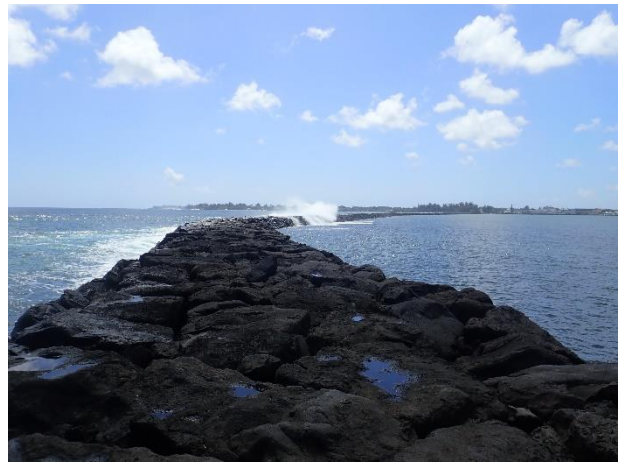
Figure 1 - Wave overtopping at Hilo Breakwater

Based on present and future wave climate as affected by sea level rise, a quantitative comparison of simulated breakwater overtopping flow rates between Boussinesq (XBeach) and CFD (OpenFOAM) wave models is investigated at high resolution, utilizing spectral output at discrete reporting stations embedded within larger 2D Boussinesq model domains to generate the forcing wave boundary conditions used for both overtopping models. Additional 3D CFD modeling at even higher fidelity will attempt to model narrow segments of the breakwater at scales sufficient to resolve individual armor stones within the armor layer profile to investigate hydrodynamic forces on these units from wave impacts.
